Fall River District Fisheries Newsletter

Lunker Structures for Bass

Root-wads or Lunker Structures for Bass Habitat?

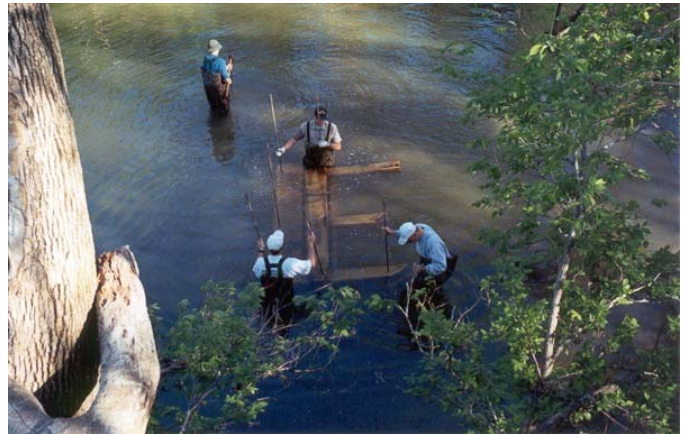
installing lunker structure

We installed the lunker structures in three different sections of Otter Creek. Four structures were placed end to end in waist deep water, making a total length of 16 feet of artificial undercut bank in each section. Nine 5/8 inch rebar rods four feet long secured each structure to the creek bottom (see picture above).

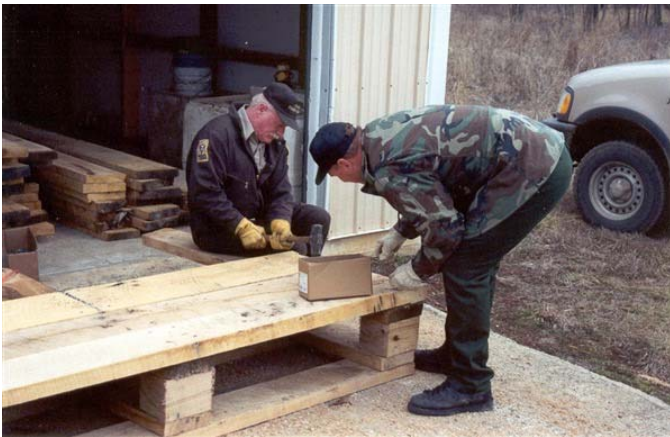
lunker structure construction

There's something very attractive about lunker structures. These things were easy to build. Everyone got in on the fun. Pictured above, Area Manager John Bills (now retired) and Conservation Officer Dan Melson drive 30 penny ring-shank pole barn nails into the tough oak planks with a sledge hammer. We used rough sawn green (not dried) oak planks, three inches thick, because they had to support a lot of weight and not rot in water. Each structure was eight feet long by two feet wide with a one foot high space for fish to occupy. We built 12 lunker structures just like this one.

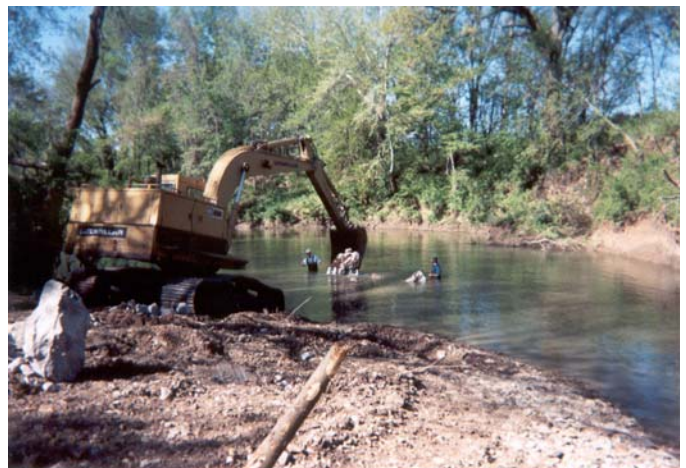
placing limestone rip-rap on lunker structures

Then a huge trackhoe was used to cover the entire section of lunker structures with limestone boulders (pictured above). To top it off, creek gravel was spread over the boulders to a thickness of about two feet (see top left picture on page 3). Anyone who's spent any time around creeks in Kansas knows about stream bank erosion. These things have withstood the test of time. They've been in place since 2001 and haven't washed

down stream. They've experienced three 25 year flood events and two 10 year flood events and they're still there providing bass habitat.

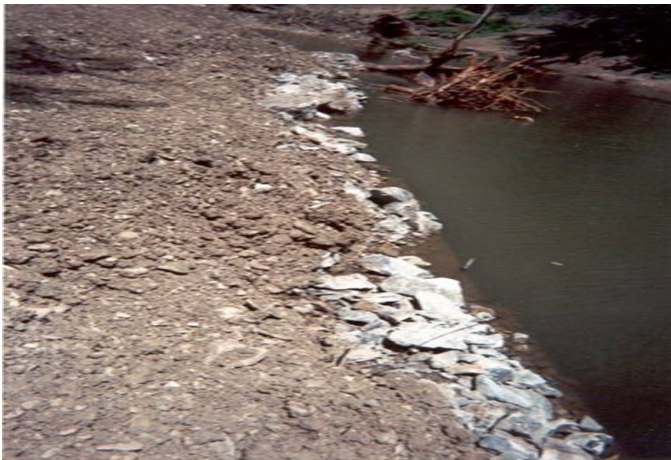
finished section of Otter Creek lunker structures

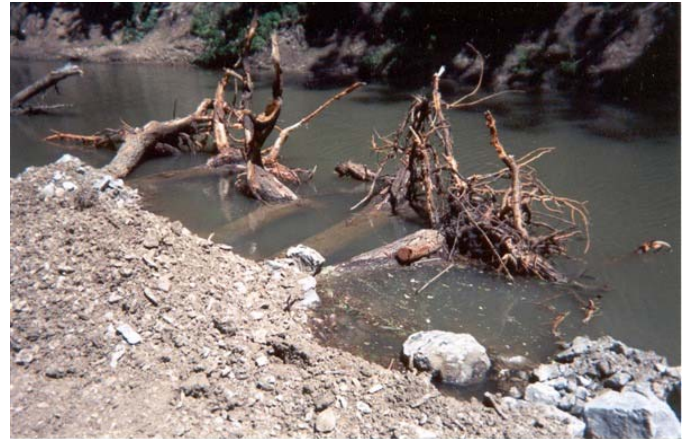
completed root-wad installation

The lunker structures provided simple overhead cover, while the root-wads provided complex overhead and mid-water cover. We also wanted to see if the spring floods would wash the root-wads out. It seemed likely that the tangled jumble of roots sticking out into the creek's main channel would catch flood debris and build up to the point that they would wash out. There's a US Geological Survey stream gauging station on the KS Highway 99 Bridge over Otter Creek. It recorded the volume of water coming down the creek during the two flood events that occurred during the project.

A large trackhoe was used to dig a trench for the tree trunks. The trunks were angled upstream at a 45 degree angle so the current would tend to push the root-wads into the bank instead of pull them out. The trackhoe was used to cover the trunks with limestone boulders. Then the boulders were covered with creek gravel. A completed root-wad structure site is pictured on the left.

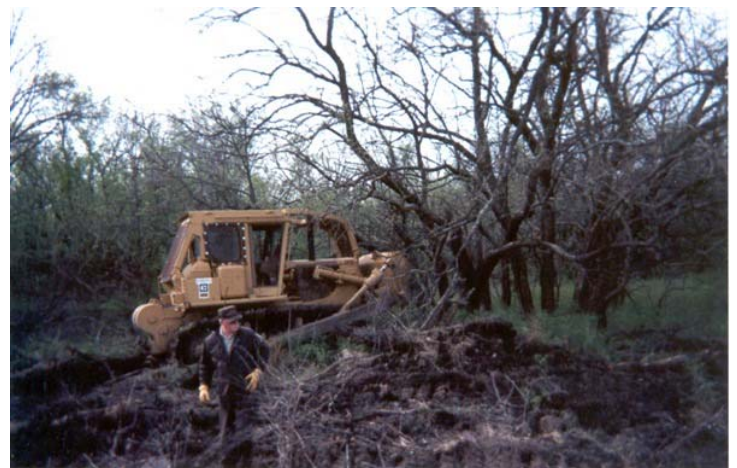
uprooting hedge trees for root wads

Construction of root-wads was simple; however it required some large equipment. Pictured above, a D-8 Caterpillar was required to push the hedge trees over, uprooting it, leaving the root system in tact. Hedge trees

were selected for their strength and rot resistance in water. The tops of the trees were cut off, leaving the roots and trunk. A front end loader was used to lift the behemoth trunks and root wads onto a gooseneck trailer for transport over to the stream sites (pictured below).

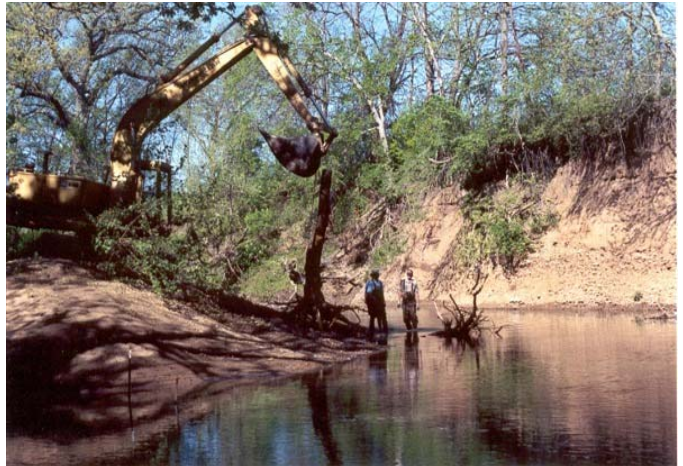
trackhoe lifting root-wad and trunk into trench

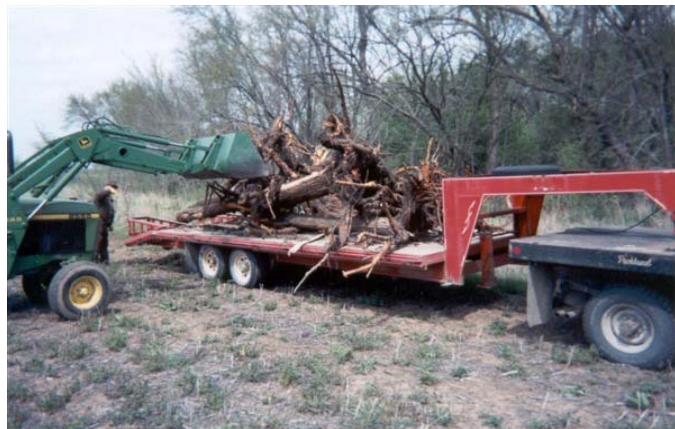
loading root-wads onto gooseneck trailer
