Cedar Bluff District Fisheries

Kansas Department of Wildlife, Parks, and Tourism
Fisheries Division

Zebra Mussels	2
Stocking Report	4
Sheridan Fishing Pier Renovation	5
Scott Habitat Enhancement	6
Lake Mapping	7

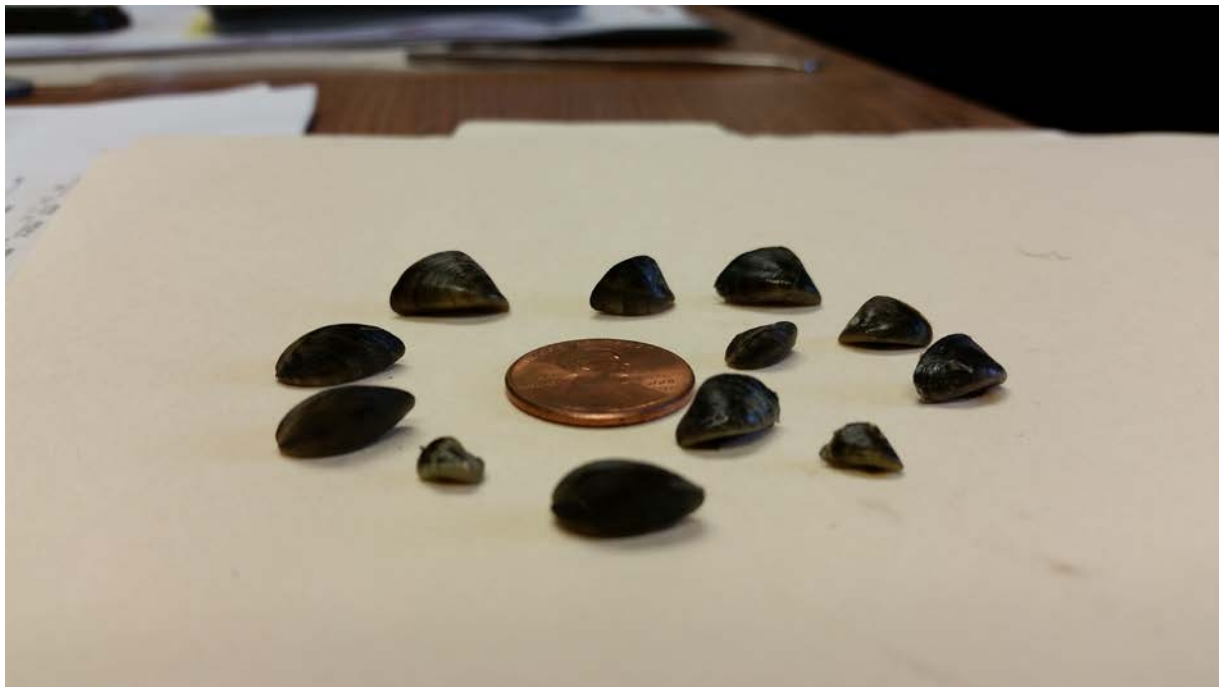
Adult zebra mussels from Cedar Bluff

Zebra mussels are dime-sized mollusks with striped, sharp-edged, two-part shells. They can produce huge populations in a short time and do not require a host fish to reproduce. A large female zebra mussel can produce 1 million eggs, and then fertilized eggs develop into

After settling, zebra mussels develop byssal threads that attach their shells to submerged hard surfaces such as rocks, piers, and flooded timber. They also attach to pipes, water intake structures, boat hulls, propellers, and submerged parts of outboard motors. As populations increase, they can clog intake pipes and prevent water treatment and electrical generating plants from drawing water. In 2012, two Kansas communities, Council Grove and Osage City experienced temporary water shortages from zebra mussel infestations before water intake structures could be cleaned up. Removing large numbers of zebra mussels to ensure adequate water flow can be labor-intensive and costly.

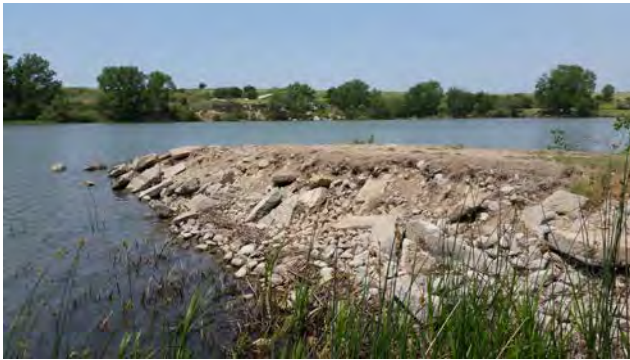
Sheridan fishing pier prior to renovation

Sheridan State Fishing Lake located approximately 11 miles east of Hoxie on state highway 24 is managed primarily for public fishing and is a popular destination for northwest Kansas anglers. As part of making Sheridan an angler-friendly facility, shoreline access was enhanced via construction of a fishing pier on the east side of the lake. After being subject to years of angler use and environmental elements the pier had become eroded.

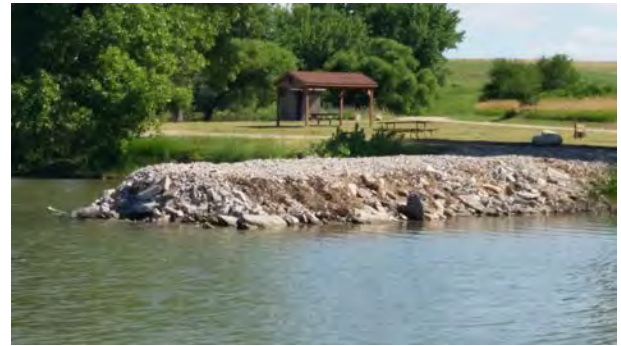
Sheridan fishing pier after renovation showing addition of new concrete

Through collaborative efforts between the Sheridan County landfill, Kansas Department of Transportation, and KDWP, chunk and crushed concrete was added to the eroded fishing pier during the spring of 2016 at minimal cost to renovate the structure. The resulting pier post-renovation is now a much wider, erosion-proof, and angler-friendly structure.

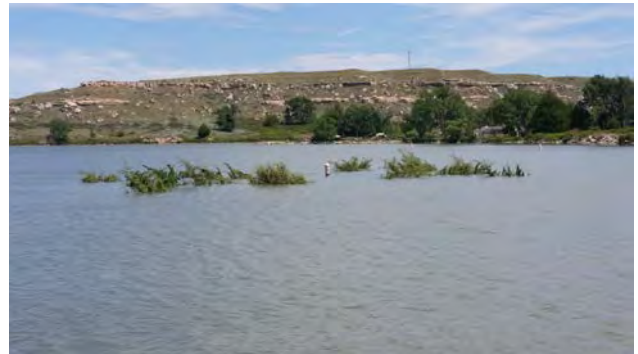
Typical open-water fish attractor composed of multiple trees

angling opportunities. Each of the structures constructed during 2010 consisted of multiple cedar trees piled together in discrete areas. During 2016, additional trees were added to each of the older structures as a maintenance step and emphasis was placed on adding trees on the nearshore side of the existing piles so that shoreline anglers could more easily cast to the brush.

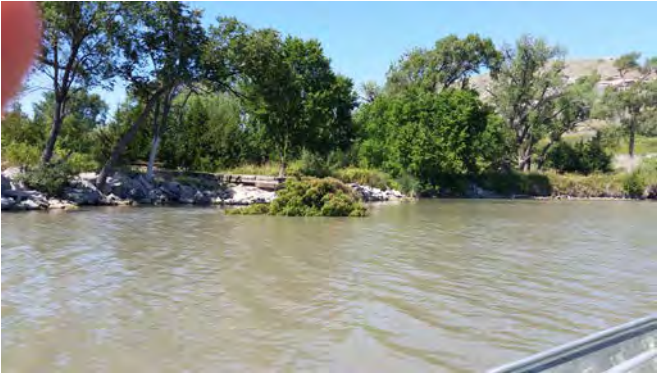
Shoreline oriented habitat structure comprised of a single tree

Diversifying shoreline habitat complexity was a priority during the 2016 habitat project, but a primary goal was to benefit shore anglers since 85 percent of fishing pressure exerted at Lake Scott is from shore. Shoreline habitat structures differed from deeper, open-water type structures in that the shoreline structures consisted of single large trees placed individually along predetermined areas. The approach in 2016 differed from that in 2010 because we had capability to load larger trees on the habitat barge made possible by the high-capacity winch installed on the barge.
