EL CUARTELEJO

Only Known Indian Pueblo in Kansas

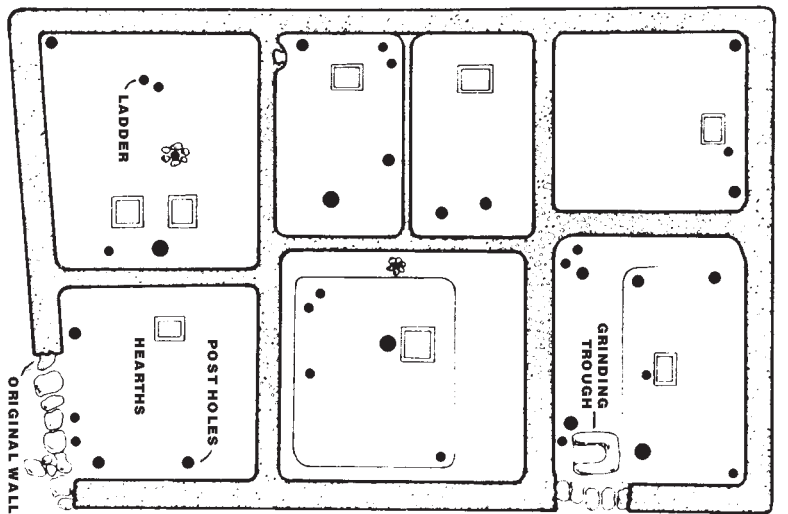
Floor Plan

Stone from the surrounding hills was used to build El Cuartelejo pueblo. Walls were plastered inside and out with adobe, and the roof was made of willow poles or brush covered with mud. When first excavated, abundant charcoal, burned tools, adobe, and quantities of the charred corn were found, all evidence that the pueblo had been destroyed by fire. There were no indications of doors or

windows, and small paired post holes in the corners of most rooms suggested entrance by ladders through openings in the roof.

After 1899 much erosion and disintegration took place. When the Kansas State Historical Society re-excavated the pueblo in 1970, portions of the stone hearths, two sections of the outer wall and several post holes were all that remained.

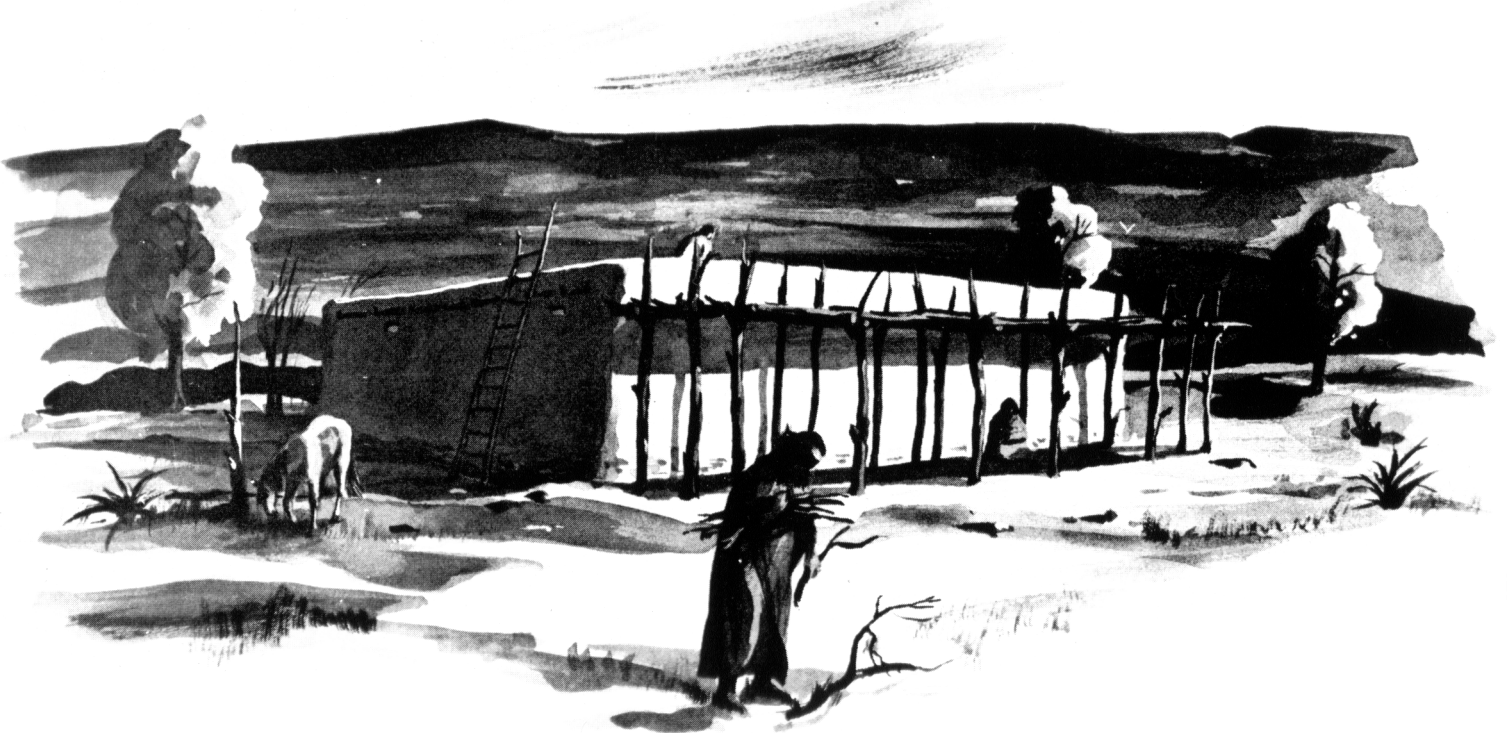
El Cuartelejo pueblo as it may have appeared when occupied.

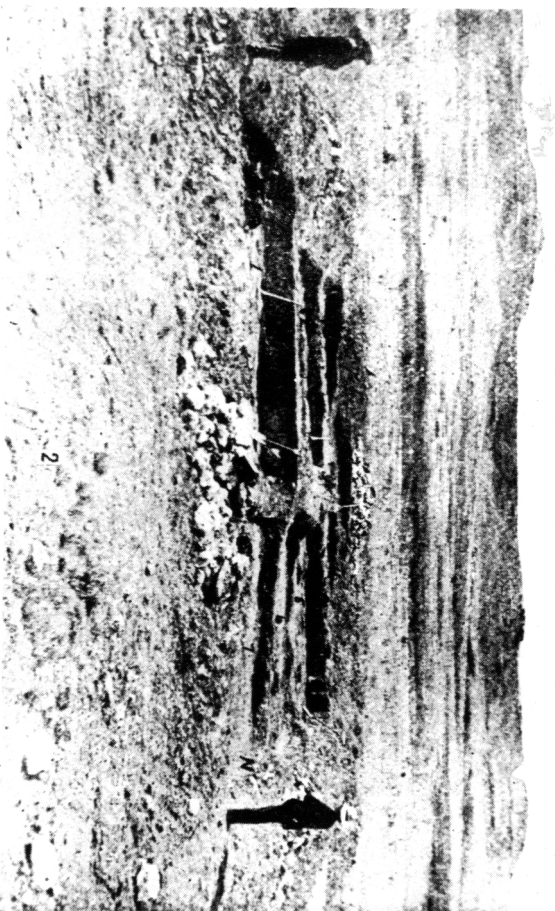
Pueblo ruins in Scott County, Kansas, investigated in 1899 by Prof. Williston and recognized as El Cuarteletejo.

In 1889, archeological excavations located and exposed the lower portions of stone walls of a pueblo in Scott County, Kansas. The ruins together with the recovered artifacts, stone and bone tools, ornaments and pottery shards characteristic of Plains Apaches led to the identification of this site as that of the historic El Cuarteletejo.

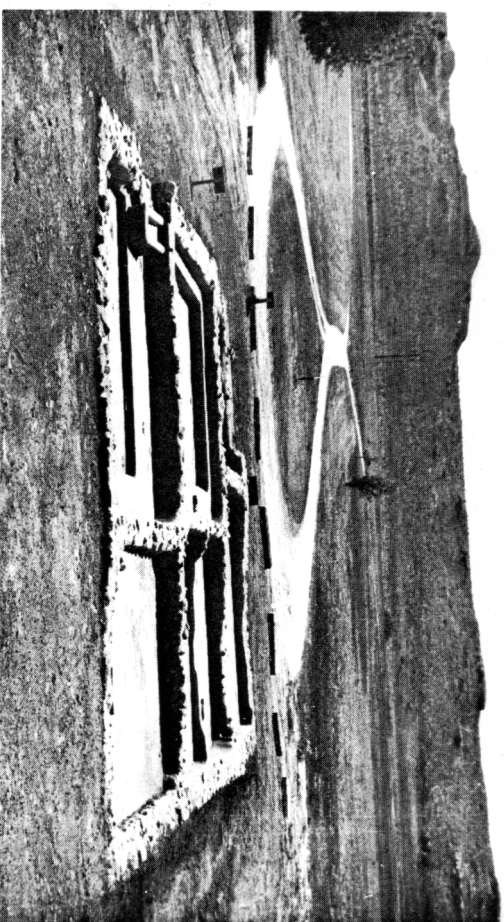
Ruins of the pueblo were re-constructed in 1971 by the Kansas State Historical Society at the El Cuarteletejo site.

In 1970, the Kansas State Historical Society undertook additional archeological investigations and reconstruction of the ruins as they were found in 1899. Interpretive markers were placed at the site, and it is open to the public throughout the year.
